# Arboricultural Report

Tree Survey,  
Arboricultural Impact Assessment &  
Arboricultural Method Statement

In relation to the Large-Scale Residential Development at:  
**on lands at Crowpark (1st Division)**  
**Kildalkey Road**  
**Trim**  
**Co. Meath**

**June 2026**

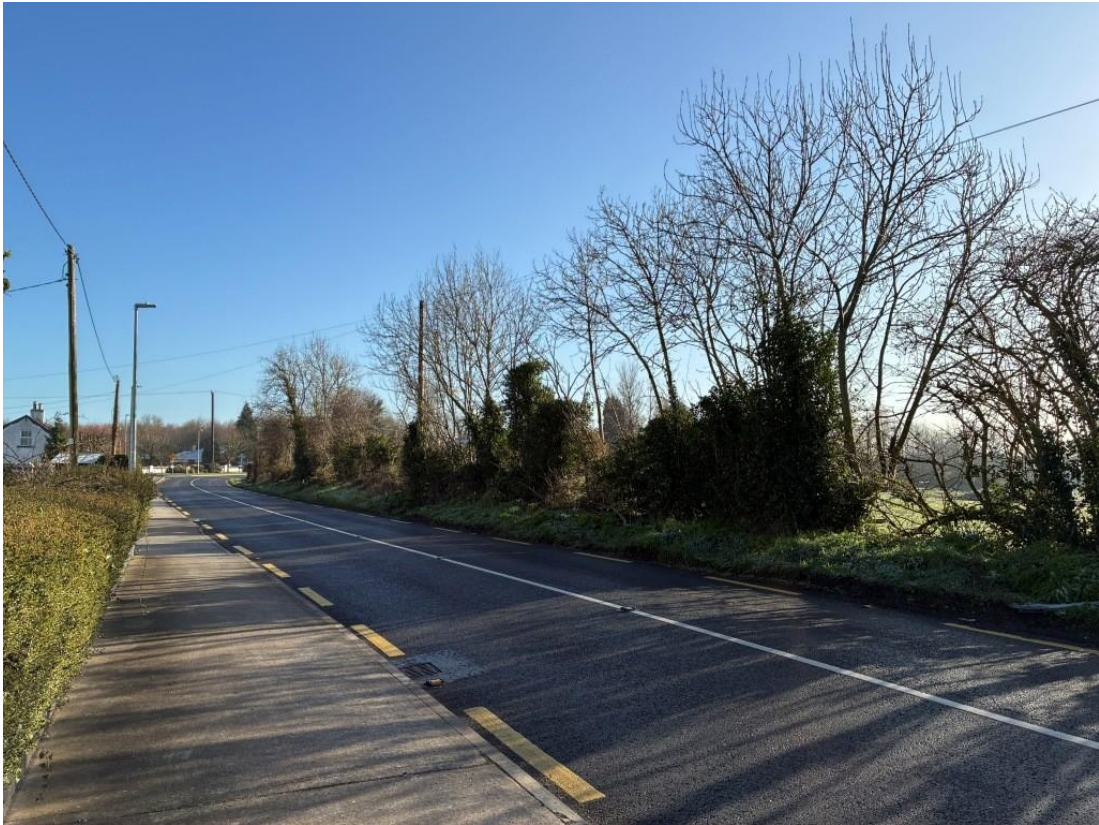
**Photo 1:** View showing the native hedgerow (H3) located adjacent to Kildalkey Road along the northern boundary.

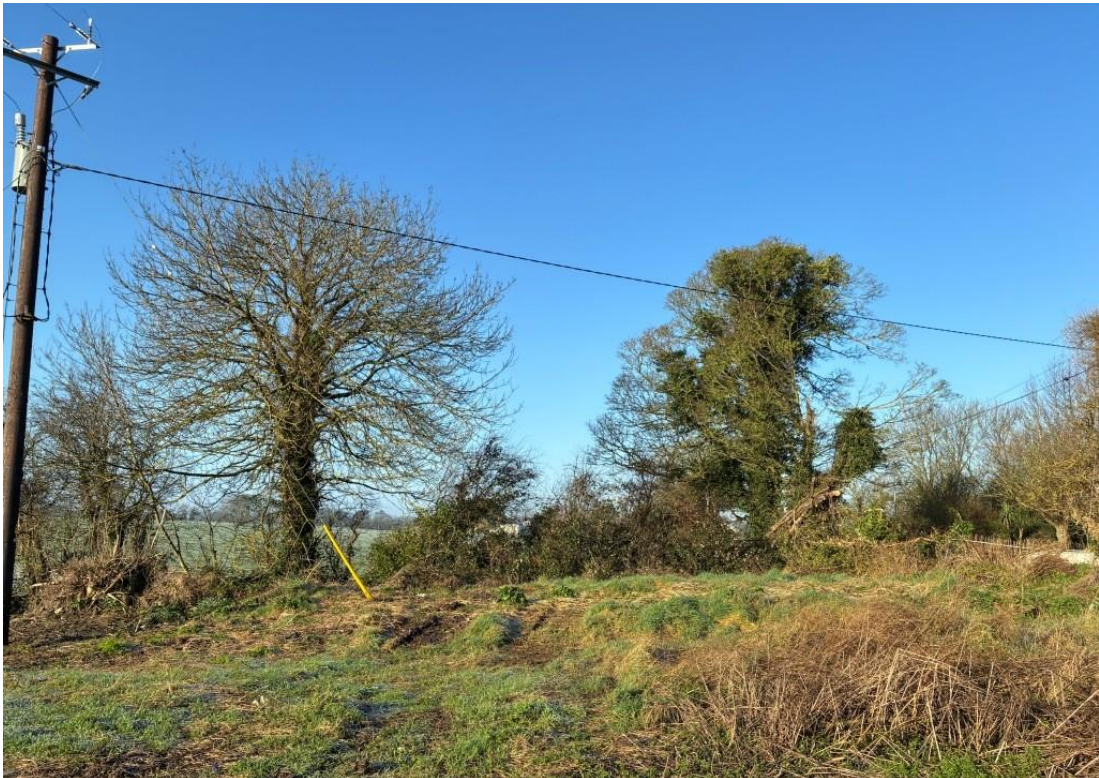
**Photo 2:** View of the sycamore trees T4 and T6 and the ash tree T7 located along the western boundary.

Tree T7	1 Fraxinus excelsior (Ash)	15.0	55	1	6.0		8.5		5.0		6.5		0.5		Mature	Structural condition Good. Physiological condition Good. Ivy or climbing plant. Tree is susceptible to Ash die back. Tree not included on topographical survey, location estimated. Unable to inspect tree closely due to ivy cover.	03/03/2026	136.8	6.6	20-40	C2	
Tree T8	1 Ulmus glabra (Wych Elm)	11.5	32	1	4.0		5.5		2.5		4.0		3.0		Semi Mature	Structural condition Poor. Physiological condition Dead. Dead tree / trees. Tree not included on topographical survey, location estimated.	03/03/2026	46.3	3.8	0-10	U	
Tree T9	1 Acer pseudoplatanus (Sycamore)	13.0	42	1	2.5		6.0		3.0		4.5		2.0		Early Mature	Structural condition Good. Physiological condition Good. Access to inspect base - Not possible. Competition - Adjacent trees. Ivy or climbing plant. Tree not included on topographical survey, location estimated. Unable to inspect tree closely due to ivy	03/03/2026	79.8	5.0	40+	B2

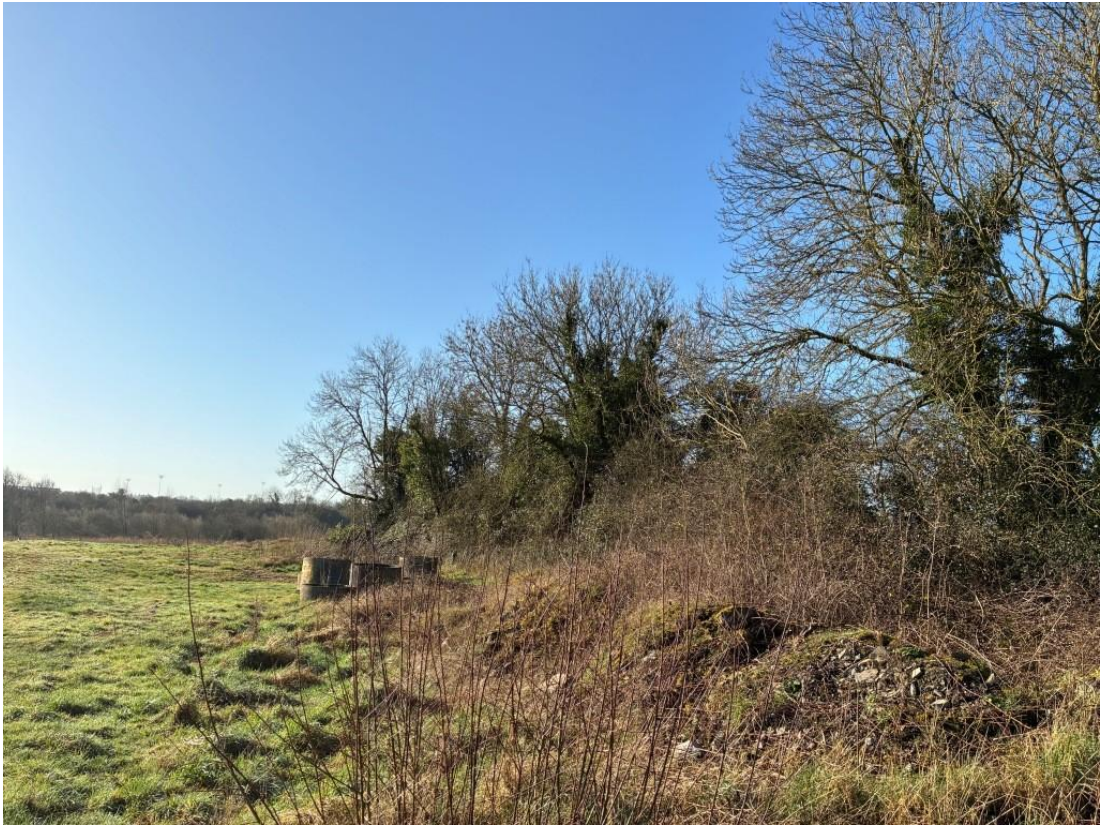
**Photo 3:** View of the mature native hedgerow H17 and tree line T7 to T16.

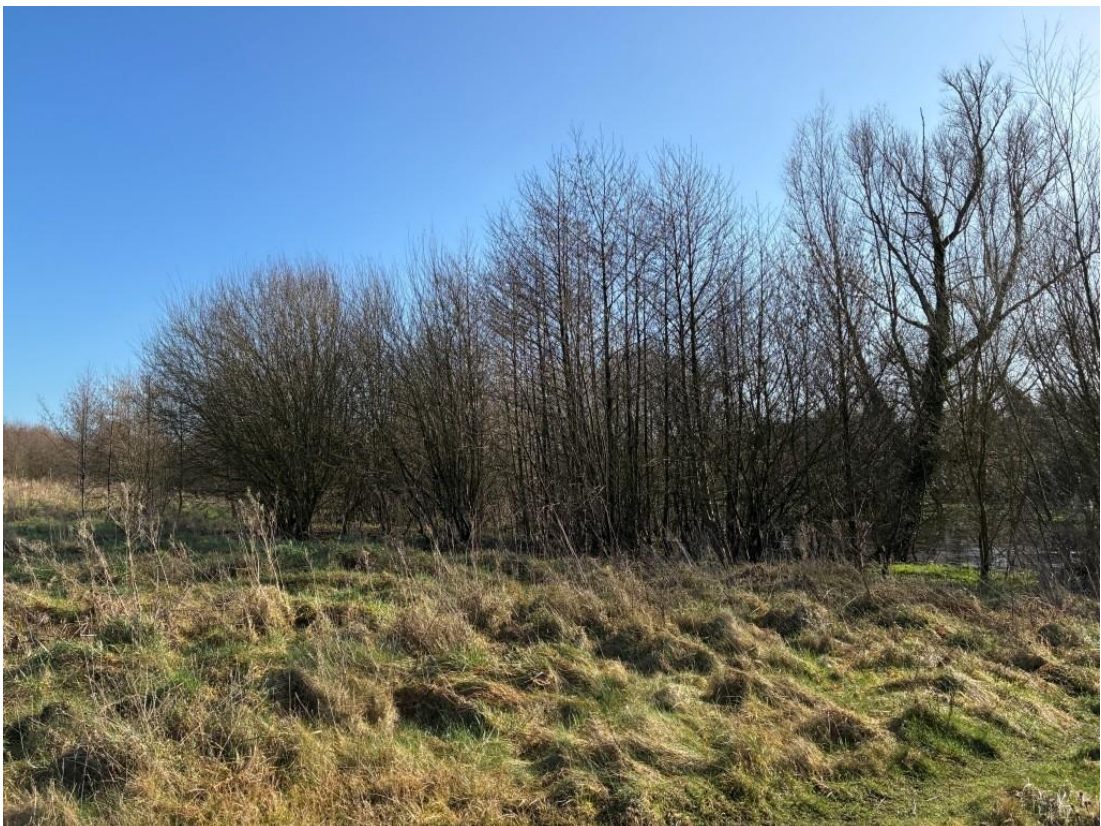
**Photo 4:** View of tree group G30 located along the southern boundary, adjacent to the River Boyne.

1 Rubus fruticosus s. (Blackberry/Bramble)																				
	1 Crataegus monogyna (Common Hawthorn/Quick/May)																				
	1 Alnus glutinosa (Common Alder)																				
Group G30	1 Salix caprea (Goat Willow/Great Sallow)	9.0	15 AVE	1									0.0		Early Mature	Structural condition Good. Physiological condition Good. Tree group mostly consisting of dense pockets of semi mature alder to the North of group growing from sunken saturated ground with occasional goat willow seen at the fringes. Further to the east is has an understory of bramble and dense ivy up more mature goat willow trees. Hawthorn also noted on occasion to the south side if this group. Quantities are not recorded, only species mix. Diameter and height recorded as average for group as a whole	03/03/2026	10.2	1.8	40+	C2
	1 Rubus fruticosus s. (Blackberry/Bramble)																				
	1 Crataegus monogyna (Common Hawthorn/Quick/May)

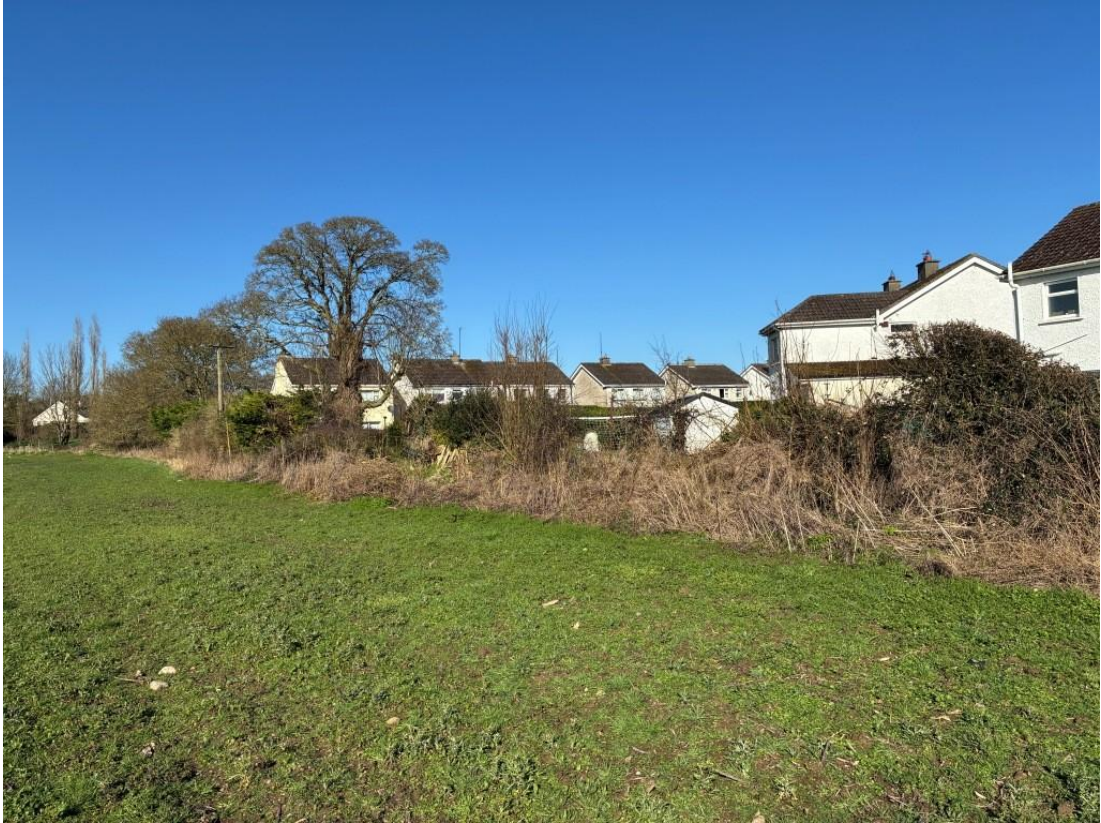
**Photo 5:** View of the tree T37 and hedge cover H35 and H36 located along the eastern boundary, adjacent to the existing residential properties.

Hedge H35	Sambucus nigra (Elder)	3.0	12 AVE	1									0.0		Mature	Structural condition Fair. Physiological condition Fair. Remains of a mixed species boundary hedge. Dense in places where thick bramble has been observed. Clematis only noted at the South end for 4m. Otherwise sparse and seen cut and managed at different heights throughout. Height and stem diameter are average for group. Quantities not recorded, only species mix. Height and stem diameter are recorded as average for group.	03/03/2026	6.5	1.4	20-40	C2					
	1 Rubus fruticosus s. (Blackberry/Bramble)																									
	1 Prunus spinosa (Blackthorn/Sloe)																									
	1 Clematis vitalba (Old Man's Beard/Traveller's Joy)																									
	1 Acer pseudoplatanus (Sycamore)

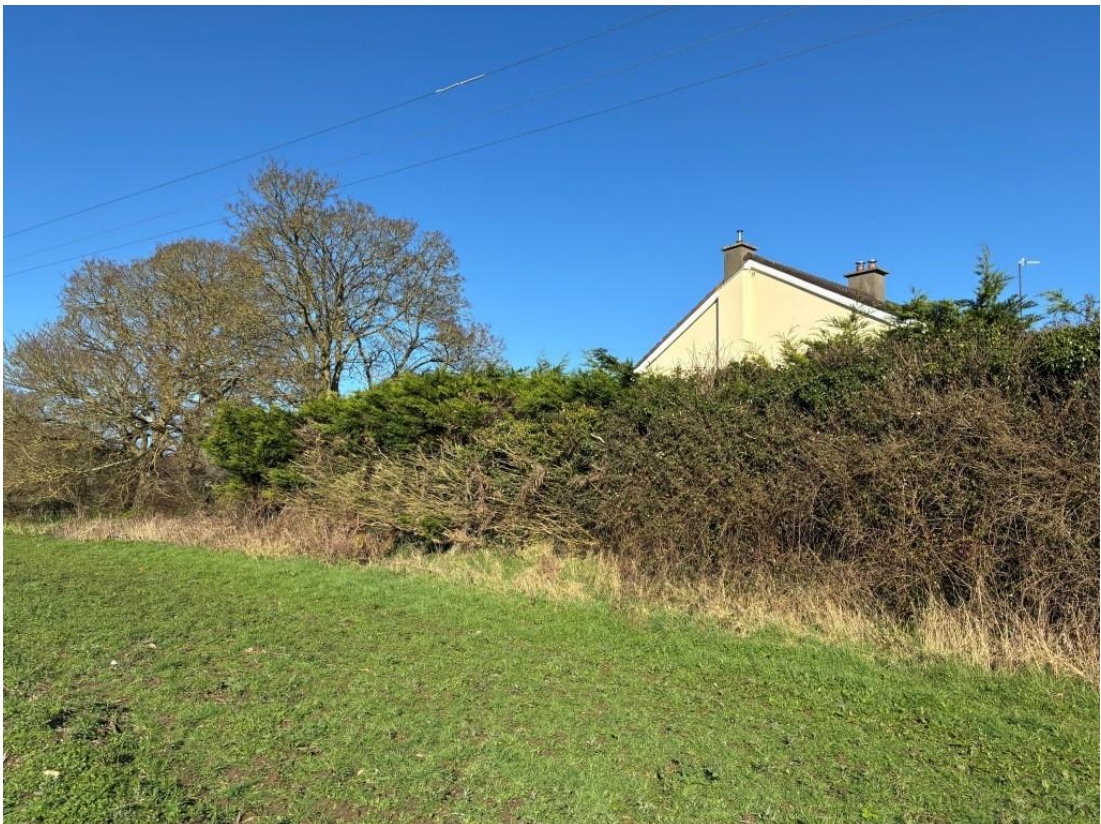
**Photo 6:** View of the Leyland cypress hedgerow H38 located adjacent to the eastern boundary.

Hedge H38	1 Sambucus nigra (Elder)	3.5	24 AVE	1									0.0		Mature	Structural condition Fair. Physiological condition Fair. Maintained Hedgerow mostly consisting of cypress. Growing in neighbouring property which is 0.5-1m above site ground level. Historically the site side has been cut back and now bramble and ivy can be noted throughout. Elder is also observed with new growth noted vigorous compared to other species. Height and stem diameter are average for group. Quantities not recorded, only species mix.	03/03/2026	26.1	2.9	20-40	C2
	1 Rubus fruticosus s. (Blackberry/Bramble)																				
	1 Hedera helix (Common Ivy)																				
	1 Cupressocyparis leylandii (Leyland Cypress)																				
Tree T39	1 Acer pseudoplatanus (Sycamore)	14.0	67	1	6.5	6.5	6.5	6.5	2.5			2.5		Mature	Structural condition Good. Physiological condition Good. Decay / structural defect in crown limb / limbs - Localised. Ivy or climbing plant. Root damage - Suspected. Shedding limb / limbs - Historic. Tree is located on neighbouring site growing from an elevated ditch/bank. Historically pollarded at 3 metres and regrown with mature principal stems. Tree not included on topographical survey, location estimated.	03/03/2026	203.1	8.0	40+	B2

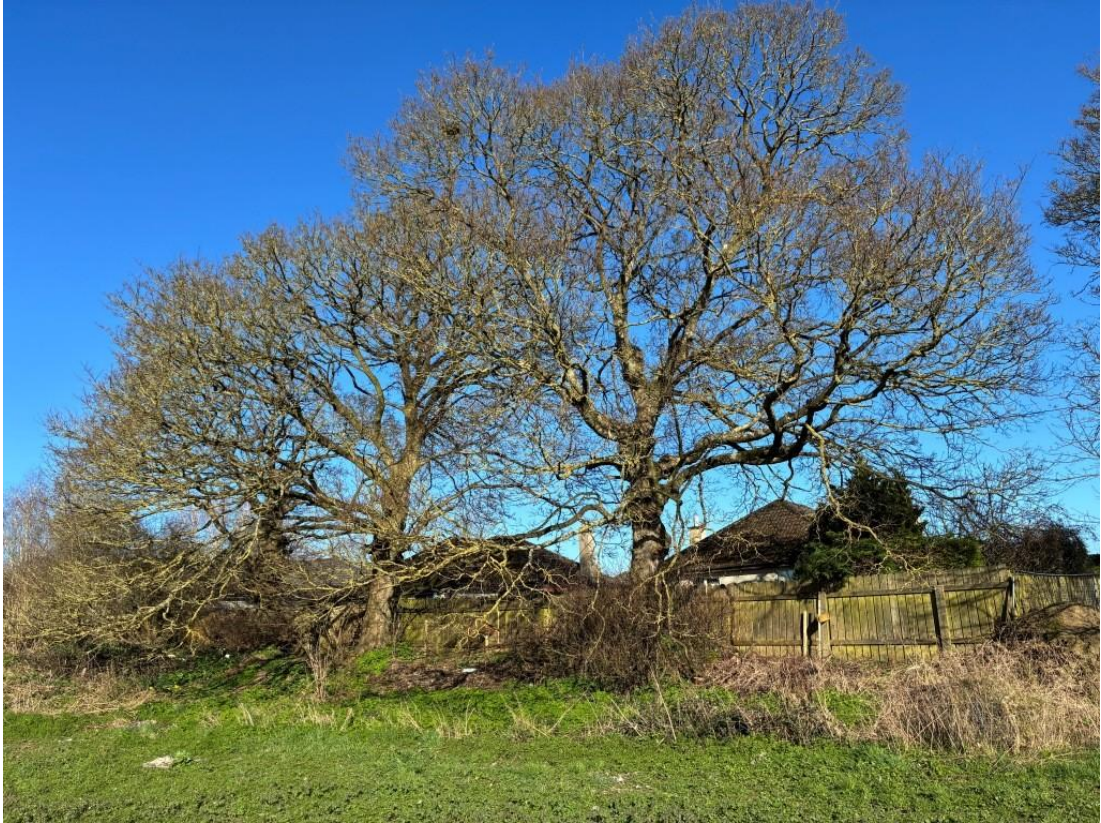
**Photo 7:** View of the mature sycamore trees T40 to T42.

Tree T42	1 Acer pseudoplatanus (Sycamore)	14.0	64	1	3.0		7.0		8.5		8.5		2.5		Mature	Structural condition Fair. Physiological condition Fair. Branch weight - Heavy. Deadwood - Minor. Epicormic growth - Base. Shedding limb / limbs - Historic. Tree is located on the property boundary. Growing from an elevated ditch/bank. Tree not included on topographical survey, location estimated.	03/03/2026	185.3	7.7	40+	B2
Group G43	1 Salix caprea (Goat Willow/Great Sallow) 1 Rubus fruticosus s. (Blackberry/Bramble) 1 Hedera helix (Common Ivy)	4.0	10 AVE	1									0.0		Semi Mature	Structural condition Fair. Physiological condition Fair. Scrub group of willow, bramble and ivy on site side.	03/03/2026	4.5	1.2	20-40	C2

- 6.7 **Tree pruning works** – Pruning works have been recommended for trees T10, T14, T40 and T42, to provide sufficient crown clearance to facilitate the development. These works are for a lateral reduction only and have been specified within the Tree Work Schedule at Appendix A.

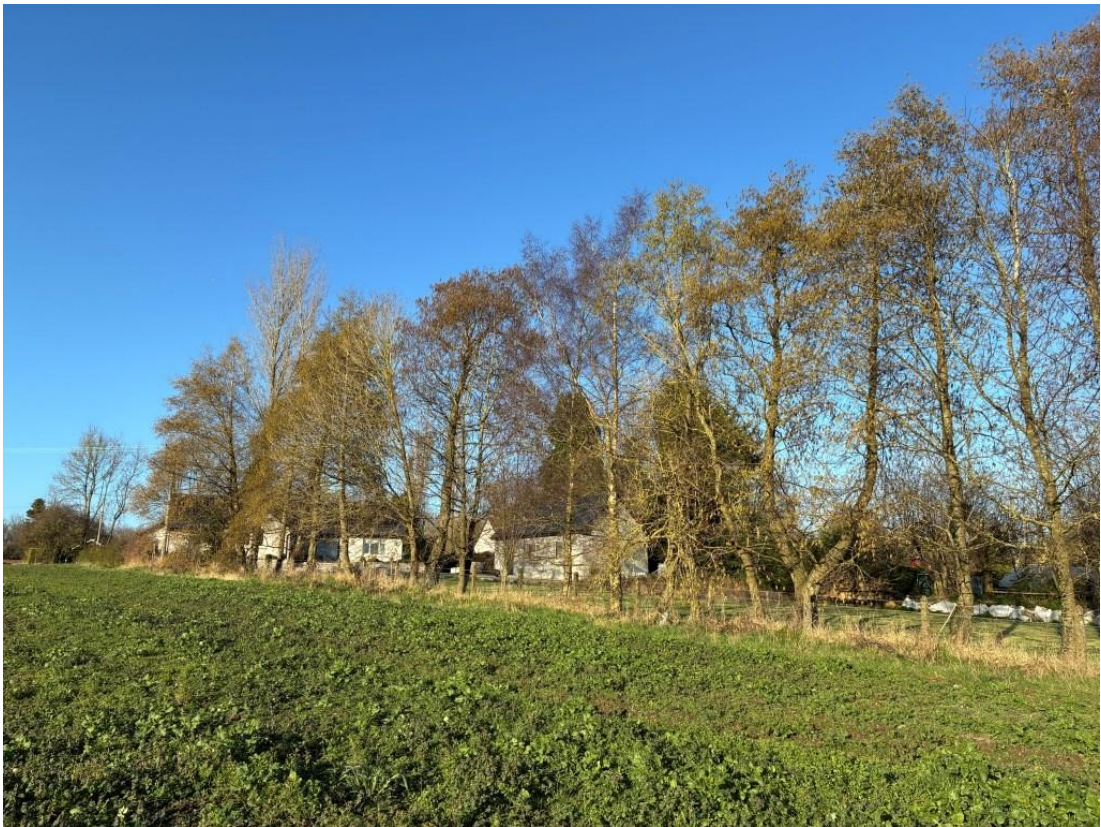
**Photo 8:** View of the early-mature tree line T60 to T82 located within the neighbouring property, adjacent to the eastern boundary.
