# Arboricultural Report

Tree Survey,  
Arboricultural Impact Assessment &  
Arboricultural Method Statement

In relation to the Large-Scale Residential Development at:  
**on lands at Crowpark (1st Division)**  
**Kildalkey Road**  
**Trim**  
**Co. Meath**

**June 2026**

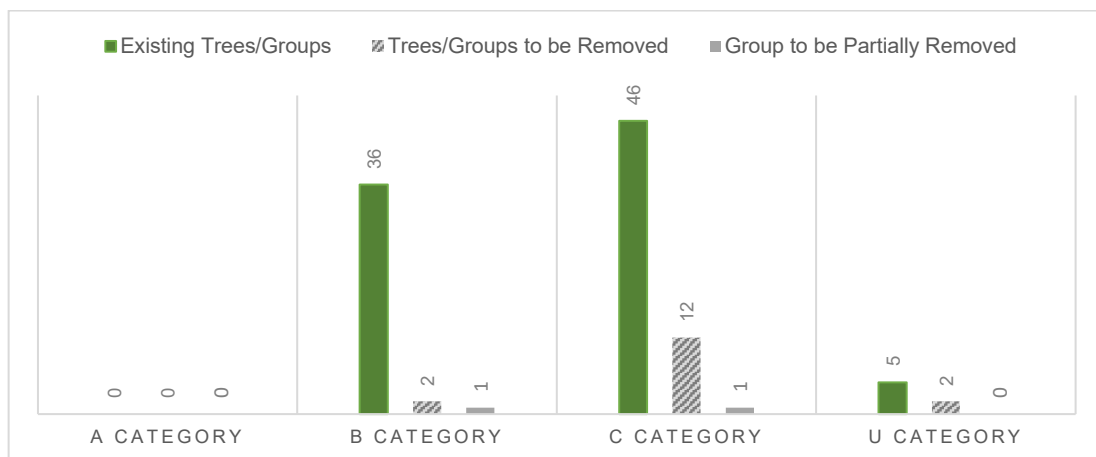
**Figure 3: Breakdown of the proposed tree removals.**

- 6.1 **Loss of trees** – The proposed development will require the removal of 2 trees and the partial removal of 1 hedgerow of moderate quality and value (B Category), 5 trees, 4 hedgerows, 2 shrub groups and 1 tree group, and the partial removal of 1 hedgerow, of low quality and value (C Category), and 2 trees of poor quality (U Category).
- 6.2 A breakdown of trees and groups to be removed according to their BS5837:2012 category is outlined in Figure 3. The proposed removals are specified within the Tree Work Schedule at Appendix A and are highlighted on the Tree Removals Plan at Appendix B.
